The Fourth International Conference on Through-life Engineering Services

## Review of Non-destructive Testing (NDT) Techniques and their applicability to thick walled composites

MR Jolly\*, A. Prabhakar, B. Sturzu, K. Hollstein, R. Singh, S. Thomas, P. Foote &amp; A. Shaw

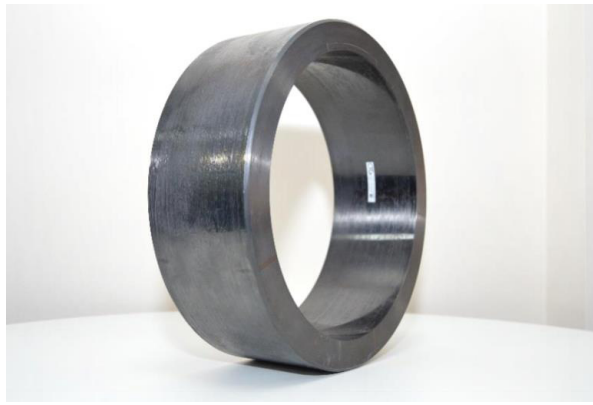
The component under consideration is an integral part of the flywheel. It is cylindrical in shape and is made out of CFRP intermediate modulus and approximately 30 mm thick (see figure 1).

The cylinder is manufactured by filament winding with an outer diameter of about 350 mm and a height of 119 mm.

Fig. 1. Composite component under consideration

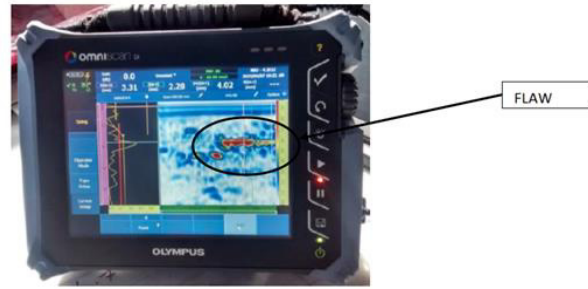
The experiment with 5MHz frequency probe detected back wall echo of material. At the same time with a 2MHz frequency probe echo signal received with larger amplitude. However, the known flaw's present in material was not noticed. There was another flaw, which was detected in C-Scan and flaw characterization shows a crack of length (figure 5).

Fig. 5. Result of experiment and analysis of sample showing flaw characteristics.

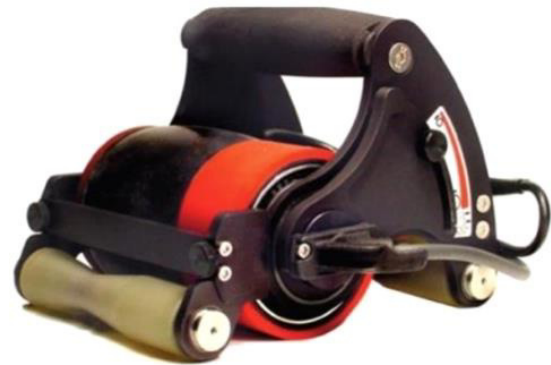
Fig. 6. Sonatest RadiusWheel Probe. [14]

The front wall echo was visible on the scanner screen. There was too much attenuation due to surface feature of the sample. The back wall echo was not detected on the screen. There could be several reasons for the lack of penetration. This could be failure of proper contact between RadiusWheel probe and flywheel due to geometry of part. The use of water as a coupling agent might have proved to be ineffective due to low viscosity and hence less adherence in between two surfaces. These factors could have led to large attenuation that were shown as near surface flaws.

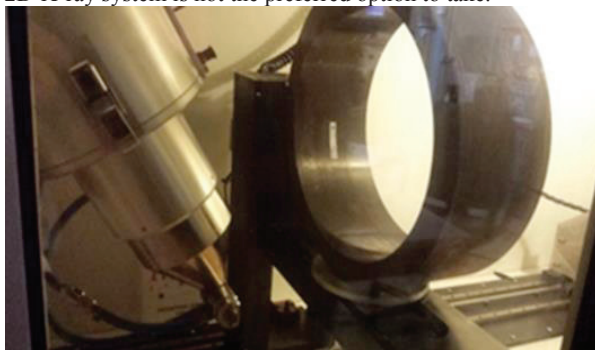
Initial tests with radiographic X-Ray equipment generating two-dimensional images have been made, figure 7 shows the experimental set-up.

Fig. 7. Experimental set-up of a 2D X-ray system.

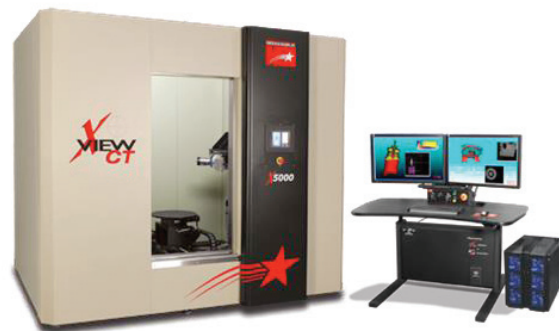
Fig. 9. North Star Imaging X5000 CT scanning system with workstation. [16]

will be presented below. Most of the companies recommended to use cabinet systems for an industrial production environment (like the one shown in figure 9). All products are state-of-the-art machines and are already used in the manufacturing industry. The price for CT scanning machines ranges from £200k to £600k, depending on precise requirements and resolution.

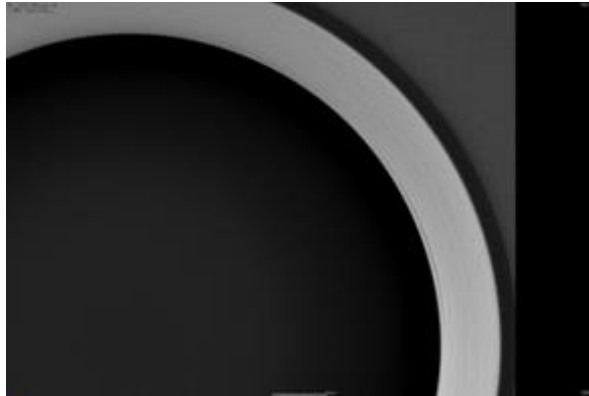
Several cabinet systems from various suppliers have been tested. Figure 10 shows results acquired with a NSI X5000 machine. A delamination on the inner side of the flywheel can clearly be seen on the right side of the picture. The data has been captured within 15 minutes with a resolution of approximately 200  $\mu\text{m}$ .

Fig. 10. Slice through the volumetric model acquired by CT scanning; the delamination on the inner side can clearly be detected

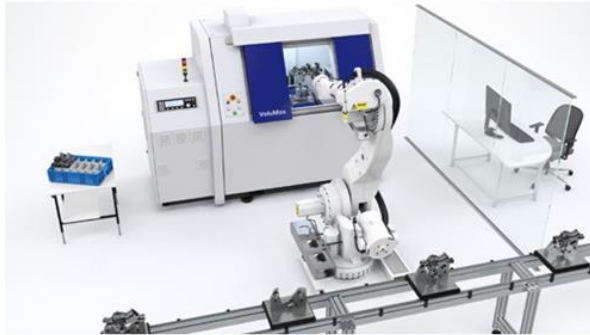
All the machines can be operated using a robotic handling system (figure 13). Opening/closing the door, starting the machine etc. can also be automated and adapted to the final production line.

Fig. 13. Fully automated in-line CT system. [19]
